**Flood Control Project Maintenance
Levee Inspections**
LMA District Cover Sheet
Spring 2017 Levee Inspection Results

Sutter Maintenance Yard Maintenance Area 0001

Spring 2017 Levee Inspection Results

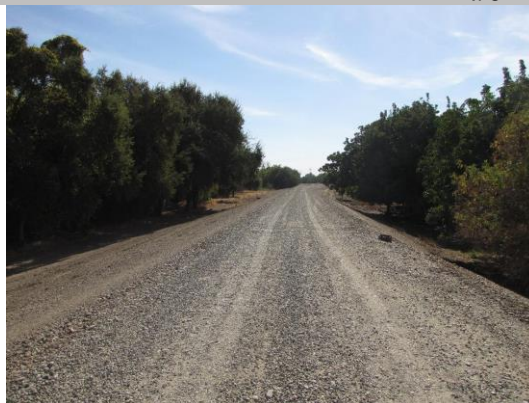
Photo 1 of 3 : UCIP_SP_2017_51872_70167.jpg

FS_ID:51872
DS_ID:16418
EP_NO: 6263
Repair Type: Non-Urgent
Crossing Status: Found
UCIP Comments: 5/3/2017 Crossing appears to be in good condition.
(DWR Sutter Yard- A Freitag)10/24/2016 Appears to be in good condition.
(DWR Sutter Yard- A Freitag)4/25/2016 Pressure gauge and valve were added to pipe near the siphon breaker on LS shoulder.
4/20/2015 Modifications are being made to pipe near the LS shoulder. Not sure what all exactly is being done.
6/23/2014 Same as last inspection. 12/17/2013 Same as last inspection. 7/18/2013 Debris cleared from in front of LS standpipe.
10/19/2012 Remove debris from landward side see photo 2. This crossing was listed in the USACE Periodic Inspection as ID#
USACE_CESPK_MA1C_2010_p_0249 however, unable to determine why crossing was marked "U".
FIELD_STRUCT_DESC: 18-inch asphalt coated steel irrigation pipe through the levee, 2 feet below the crown. Siphon breaker on the landside (LS) shoulder. Corrugated metal pipe (CMP) riser located on the LS connects with concrete V-ditch. Dual slant pumps and gate valves on the bank approximately 215 feet from waterside (WS) toe. Pump feeds into single 18-inch steel pipe. 2-inch electrical conduit buried in the same trench as the irrigation pipe. (Permit No. 6263, 1968 - C. Tuttle) [Additional Reference(s): DWR Levee Log, 1992].

Overview of levee crown looking downstream at crossing.

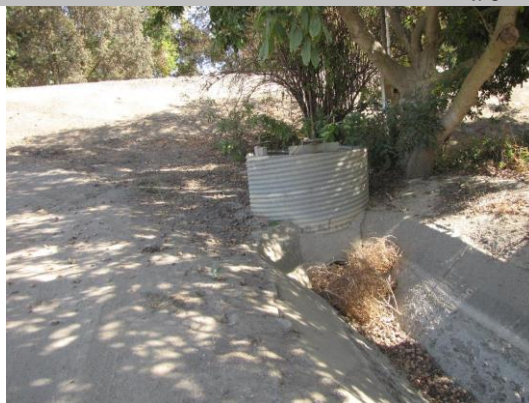
Photo 2 of 3 : UCIP_SP_2017_51872_70166.jpg

CMP riser and concrete lined v-ditch located on LS toe.

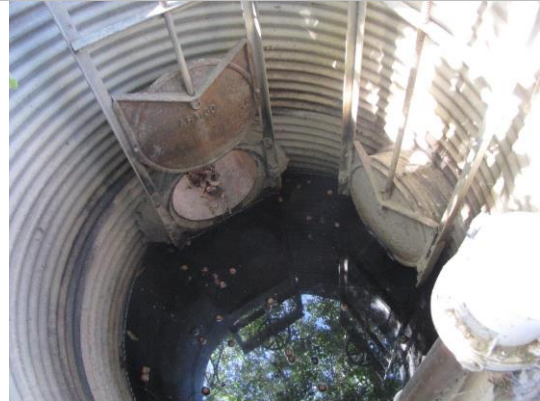
Photo 3 of 3 : UCIP_SP_2017_51872_70171.jpg

Item	DWR UCIP Field Study			39.272829 °	39.272829 °	
				-122.023282 °	-122.023282 °	
DWR ID						
Comment Code						
Inspector Comment						
FS_ID:51872 DS_ID:16418 EP_NO: 6263 Repair Type: Non-Urgent Crossing Status: Found UCIP Comments: 5/3/2017 Crossing appears to be in good condition. (DWR Sutter Yard- A Freitag)10/24/2016 Appears to be in good condition.(DWR Sutter Yard- A Freitag)4/25/2016 Pressure gauge and valve were added to pipe near the siphon breaker on LS shoulder.4/20/2015 Modifications are being made to pipe near the LS shoulder. Not sure what all exactly is being done.6/23/2014 Same as last inspection. 12/17/2013 Same as last inspection.7/18/2013 Debris cleared from in front of LS standpipe.10/19/2012 Remove debris from landward side see photo 2. This crossing was listed in the USACE Periodic Inspection as ID# USACE_CESPK_MA1C_2010_p_0249 however, unable to determine why crossing was marked "U". FIELD_STRUCT_DESC: 18-inch asphalt coated steel irrigation pipe through the levee, 2 feet below the crown. Siphon breaker on the landside (LS) shoulder. Corrugated metal pipe (CMP) riser located on the LS connects with concrete V-ditch. Dual slant pumps and gate valves on the bank approximately 215 feet from waterside (WS) toe. Pump feeds into single 18-inch steel pipe. 2-inch electrical conduit buried in the same trench as the irrigation pipe. (Permit No. 6263, 1968 - C. Tuttle) [Additional Reference(s): DWR Levee Log, 1992]. FS Date: 5/23/2017 10:05:22 AM

Photo 1 of 2 inside view of CMP riser located on LS toe.

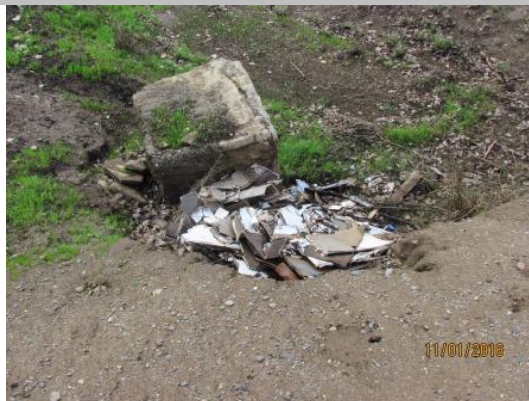
Photo 1 of 2 : SP_2017_MA0001_297_114_20170315_00045.jpg

LM Start	6.23	Rating **	M	Issue No.	114
LM End	6.23	Issue Type +	En	Location *	LS
Category	Earthen Levee			GPS Latitude/Longitude	
				Start	End
Item	Encroachments			39.279293 °	39.279293 °
				-122.022537 °	-122.022537 °
DWR ID	DWR_MA0001_01_f_2016_114				
Comment Code					
DE : Debris					
Inspector Comment					
Debris found along landside toe on both sides of the ramp (dry wall debris used for erosion control and brick/concrete debris on landside toe.)

View of the dry wall debris used for erosion control along the downstream side of the ramp.

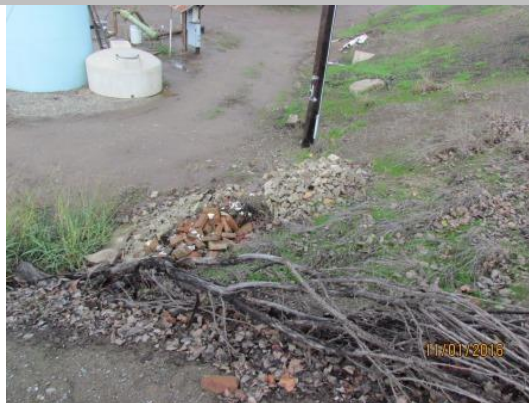
Photo 2 of 2 : SP_2017_MA0001_297_114_20170315_00046.jpg

LM Start	6.23	Rating **	M	Issue No.	114 (cont)	
LM End	6.23	Issue Type +	En	Location *	LS	
Category	Earthen Levee			GPS Latitude/Longitude		
				Start		End
Item	Encroachments			39.279293 °	39.279293 °	
				-122.022537 °	-122.022537 °	
DWR ID	DWR_MA0001_01_f_2016_114					
Comment Code						
DE : Debris						
Inspector Comment						
Debris found along landside toe on both sides of the ramp (dry wall debris used for erosion control and brick/concrete debris on landside toe.)

View of the bricks and concrete debris along the upstream side of the ramp.

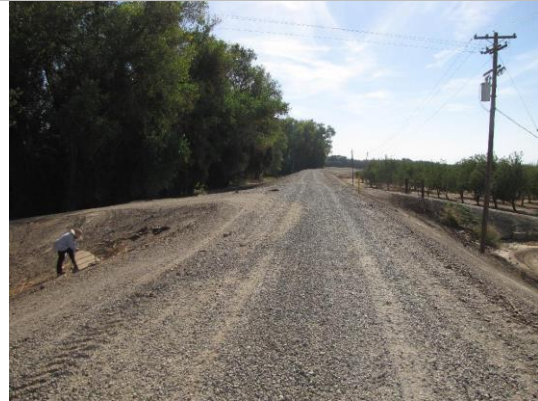
Photo 1 of 3 : UCIP_SP_2017_51873_70174.jpg

FS_ID:51873
DS_ID:16446
EP_NO: N/A
Repair Type: Urgent
Crossing Status: Found
UCIP Comments: 5/3/2017 Pipe leaked during the Jan/Feb 2017 high water event. Sand bags were placed at both the LS and WS outlets as well as down inside the standpipe to slow the water flow. The 5inch pvc was cut away but the slide gate could still not close fully. Suspect sediment build up was in the bottom of the stand pipe was blocking the gate. Inside of pipe should be cleaned out. (DWR Sutter Yard-AFreitag)10/24/2016 Pvc was back running through the crossing and blocking the screwgate. photo attached(DWR Sutter Yard-AFreitag)9/28/2016 Crossing has been downgraded from Urgent to Non-Urgent 5-inch PVC pipe was cut to allow the slide gate to close. Need to contact owner to remove unauthorized pipe to comply with Title 23. (DWR UCIP - omagana)4/25/2016 5 inch pvc pipe running through crossing has been cut out to allow the slide gate to close. (DWR Sutter Yard - afreitag)4/20/2015 5inch pvc is still present blocking slide gate from closing. WS end of pipe has been exposed so there is no way to stop water from flowing through pipe during highwater times. (DWR Sutter Yard - afreitag)6/23/2014 Same as last inspection. There is no way to stop water from flowing through pipe during high water times. (DWR Sutter Yard - afreitag)12/17/2013 Same as last inspection. (DWR Sutter Yard - afreitag)7/18/2013 Same as last inspection. (DWR Sutter Yard - afreitag)10/19/2012 Unauthorized 5 inch PVC pipe running through 36 inch crossing. 5 inch PVC crossing prevents slide gate from closing during high water. Debris and sediment inside riser. This crossing was listed in the USACE Periodic Inspection as ID# USACE_CESPK_MA1C_2010_p_0258 for 5 inch PVC pipe running through culvert. (DWR UCIP - omagana) FIELD_STRUCT_DESC: 36-inch steel (not corrugated metal, as referenced in O&M manual) drainage pipe through the levee, approximately 14-16 feet below levee crown. Slide gate in corrugated metal pipe (CMP) riser on the waterside (WS) slope. Pipe also visible on the landside (LS). [Additional Reference(s): DWR Levee Log, 1992. USACE Sacramento O&M Manual 137, August 1955, (Station 331+31)]. FS Date: 5/23/2017 10:07:43 AM

Overview of levee crown looking downstream at crossing.

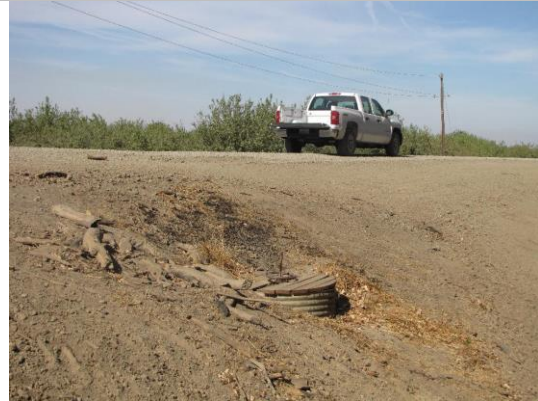
Photo 2 of 3 : UCIP_SP_2017_51873_70176.jpg

FS_ID:51873
DS_ID:16446
EP_NO: N/A
Repair Type: Urgent
Crossing Status: Found
UCIP Comments: 5/3/2017 Pipe leaked during the Jan/Feb 2017 high water event. Sand bags were placed at both the LS and WS outlets as well as down inside the standpipe to slow the water flow. The 5inch pvc was cut away but the slide gate could still not close fully. Suspect sediment build up was in the bottom of the stand pipe was blocking the gate. Inside of pipe should be cleaned out. (DWR Sutter Yard-AFreitag)10/24/2016 Pvc was back running through the crossing and blocking the screwgate. photo attached(DWR Sutter Yard-AFreitag)9/28/2016 Crossing has been downgraded from Urgent to Non-Urgent 5-inch PVC pipe was cut to allow the slide gate to close. Need to contact owner to remove unauthorized pipe to comply with Title 23. (DWR UCIP - omagana)4/25/2016 5 inch pvc pipe running through crossing has been cut out to allow the slide gate to close. (DWR Sutter Yard - afreitag)4/20/2015 5inch pvc is still present blocking slide gate from closing. WS end of pipe has been exposed so there is no way to stop water from flowing through pipe during highwater times. (DWR Sutter Yard - afreitag)6/23/2014 Same as last inspection. There is no way to stop water from flowing through pipe during high water times. (DWR Sutter Yard - afreitag)12/17/2013 Same as last inspection. (DWR Sutter Yard - afreitag)7/18/2013 Same as last inspection. (DWR Sutter Yard - afreitag)10/19/2012 Unauthorized 5 inch PVC pipe running through 36 inch crossing. 5 inch PVC crossing prevents slide gate from closing during high water. Debris and sediment inside riser. This crossing was listed in the USACE Periodic Inspection as ID# USACE_CESPK_MA1C_2010_p_0258 for 5 inch PVC pipe running through culvert. (DWR UCIP - omagana) FIELD_STRUCT_DESC: 36-inch steel (not corrugated metal, as referenced in O&M manual) drainage pipe through the levee, approximately 14-16 feet below levee crown. Slide gate in corrugated metal pipe (CMP) riser on the waterside (WS) slope. Pipe also visible on the landside (LS). [Additional Reference(s): DWR Levee Log, 1992. USACE Sacramento O&M Manual 137, August 1955, (Station 331+31)]. FS Date: 5/23/2017 10:07:43 AM

CMP riser located on WS slope.

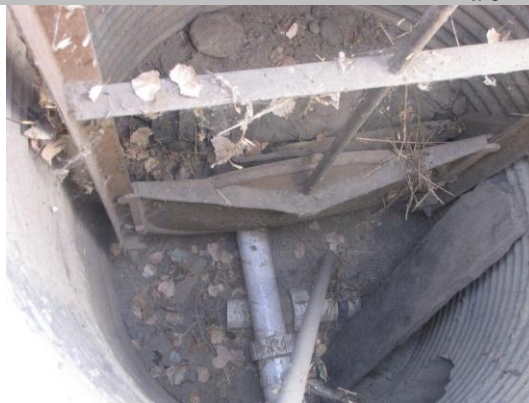
Photo 3 of 3 : UCIP_SP_2017_51873_70175.jpg

FS_ID:51873
DS_ID:16446
EP_NO: N/A
Repair Type: Urgent
Crossing Status: Found
UCIP Comments: 5/3/2017 Pipe leaked during the Jan/Feb 2017 high water event. Sand bags were placed at both the LS and WS outlets as well as down inside the standpipe to slow the water flow. The 5inch pvc was cut away but the slide gate could still not close fully. Suspect sediment build up was in the bottom of the stand pipe was blocking the gate. Inside of pipe should be cleaned out. (DWR Sutter Yard-AFreitag)10/24/2016 Pvc was back running through the crossing and blocking the screwgate. photo attached(DWR Sutter Yard-AFreitag)9/28/2016 Crossing has been downgraded from Urgent to Non-Urgent 5-inch PVC pipe was cut to allow the slide gate to close. Need to contact owner to remove unauthorized pipe to comply with Title 23. (DWR UCIP - omagana)4/25/2016 5 inch pvc pipe running through crossing has been cut out to allow the slide gate to close. (DWR Sutter Yard - afreitag)4/20/2015 5inch pvc is still present blocking slide gate from closing. WS end of pipe has been exposed so there is no way to stop water from flowing through pipe during highwater times. (DWR Sutter Yard - afreitag)6/23/2014 Same as last inspection. There is no way to stop water from flowing through pipe during high water times. (DWR Sutter Yard - afreitag)12/17/2013 Same as last inspection. (DWR Sutter Yard - afreitag)7/18/2013 Same as last inspection. (DWR Sutter Yard - afreitag)10/19/2012 Unauthorized 5 inch PVC pipe running through 36 inch crossing. 5 inch PVC crossing prevents slide gate from closing during high water. Debris and sediment inside riser. This crossing was listed in the USACE Periodic Inspection as ID# USACE_CESPK_MA1C_2010_p_0258 for 5 inch PVC pipe running through culvert. (DWR UCIP - omagana) FIELD_STRUCT_DESC: 36-inch steel (not corrugated metal, as referenced in O&M manual) drainage pipe through the levee, approximately 14-16 feet below levee crown. Slide gate in corrugated metal pipe (CMP) riser on the waterside (WS) slope. Pipe also visible on the landside (LS). [Additional Reference(s): DWR Levee Log, 1992. USACE Sacramento O&M Manual 137, August 1955, (Station 331+31)]. FS Date: 5/23/2017 10:07:43 AM

WS-Inside view of CMP riser, 5-inch pipe through 36-inch drainage pipe.

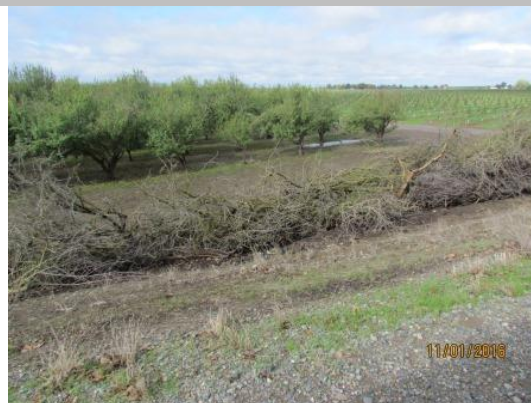
Photo 1 of 1 : SP_2017_MA0001_297_115_20170315_00047.jpg

LM Start	6.38	Rating **	M	Issue No.	115
LM End	6.38	Issue Type +	En	Location *	LS
Category	Earthen Levee		GPS Latitude/Longitude		
			Start	End	
Item	Encroachments		39.281425 °	39.281425 °	
			-122.022000 °	-122.022000 °	
DWR ID	DWR_MA0001_01_f_2016_115				
Comment Code					
PR : Prunings					
Inspector Comment					
Remove prunings from the landside toe.

View of the prunings along the landside toe.

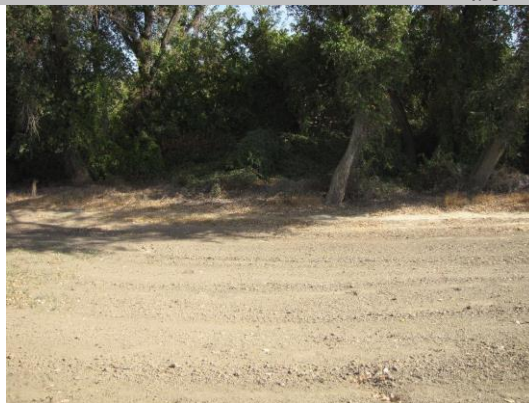
Photo 1 of 3 : UCIP_SP_2017_51874_70181.jpg

FS_ID:51874
DS_ID:16425
EP_NO: N/A
Repair Type: Non-Urgent
Crossing Status: Found
UCIP Comments: 5/3/2017 Abandoned- needs to be done properly.
(DWR Sutter Yard- A Freitag)10/24/2016 Abandoned(DWR Sutter Yard- A Freitag)4/25/2016 Abandoned crossing.4/20/2015 Same as last inspection.6/23/2014 Same as last inspection.12/17/2013 Same as last inspection.7/18/2013 Same as last inspection.10/19/2012 Need to be properly abandoned concrete structure; plate covers concrete box; Concrete headwall damaged. This crossing was listed in the USACE Periodic Inspection as ID# USACE_CESPK_MA1C_2010_p_0262 for damage to concrete structure (vertical 2 inch wide cracks and spalling visible).
FIELD_STRUCT_DESC: *ABANDONED* 72-inch corrugated metal (precast concrete) drainage pipe through the levee at an unknown depth below the crown. Structure is blocked on the waterside (WS) end with 3-foot concrete plug installed in 1980. Slide gate in concrete well on the landside (LS) shoulder. Concrete headwall at both toes. WS headwall not found. [Additional Reference(s): DWR Levee Log, 1992. USACE Sacramento O&M Manual 137, August 1955, (Station 339+74)].

View of WS no structure features visible.

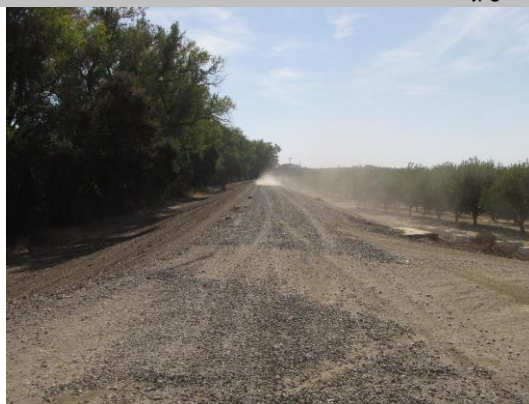
Photo 2 of 3 : UCIP_SP_2017_51874_70180.jpg

Overview of levee crown looking downstream at crossing.

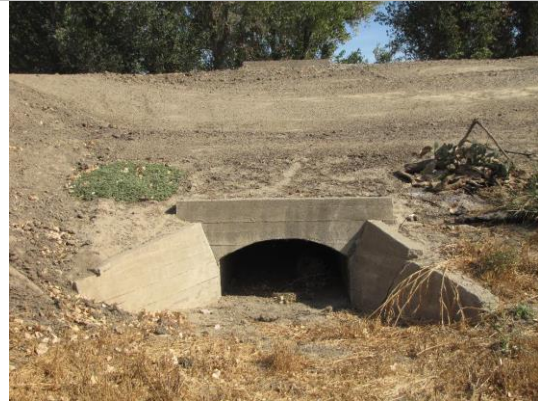
Photo 3 of 3 : UCIP_SP_2017_51874_70179.jpg

Item	DWR UCIP LMA Responsibility			39.281721 °	39.281721 °	
				-122.021894 °	-122.021894 °	
DWR ID						
Comment Code						
Inspector Comment						
FS_ID:51874 DS_ID:16425 EP_NO: N/A Repair Type: Non-Urgent Crossing Status: Found UCIP Comments: 5/3/2017 Abandoned- needs to be done properly. (DWR Sutter Yard- A Freitag)10/24/2016 Abandoned(DWR Sutter Yard- A Freitag)4/25/2016 Abandoned crossing.4/20/2015 Same as last inspection.6/23/2014 Same as last inspection.12/17/2013 Same as last inspection.7/18/2013 Same as last inspection.10/19/2012 Need to be properly abandoned concrete structure; plate covers concrete box; Concrete headwall damaged. This crossing was listed in the USACE Periodic Inspection as ID# USACE_CESPK_MA1C_2010_p_0262 for damage to concrete structure (vertical 2 inch wide cracks and spalling visible). FIELD_STRUCT_DESC: *ABANDONED* 72-inch corrugated metal (precast concrete) drainage pipe through the levee at an unknown depth below the crown. Structure is blocked on the waterside (WS) end with 3-foot concrete plug installed in 1980. Slide gate in concrete well on the landside (LS) shoulder. Concrete headwall at both toes. WS headwall not found. [Additional Reference(s): DWR Levee Log, 1992. USACE Sacramento O&M Manual 137, August 1955, (Station 339+74)]. FS Date: 5/23/2017 10:13:24 AM

View of structure located in LS.

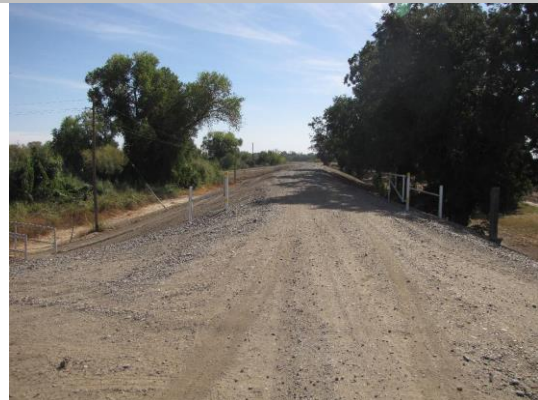
Photo 1 of 3 : UCIP_SP_2017_51875_70188.jpg

Comment Code					
Inspector Comment					
FS_ID:51875 DS_ID:16427 EP_NO: 9482 Repair Type: Non-Urgent Crossing Status: Found UCIP Comments: 5/3/2017 Abandoned- Needs to be done properly. (DWR Sutter Yard- A Freitag)10/24/2016 Abandoned.(DWR Sutter Yard- A Freitag)4/25/2016 Abandoned pipe. Needs to be properly plugged if it never gets used.4/20/2015 Same as last inspection. Structure is still buried.6/23/2014 Same as last inspection.12/17/2013 Same as last inspection.7/18/2013 Same as last inspection.10/19/2012 Structure is buried and non-operational. This crossing was listed in the USACE Periodic Inspection as ID# USACE_CESPK_MA1C_2010_p_0288 for sluice gate closed and backfilled on WS and full of sediment with wingwall cracked on LS. FIELD_STRUCT_DESC: *ABANDONED* 1 of 2: 36-inch reinforced concrete irrigation pipe through the levee at approximately 18 feet below the crown. Wooden slide gates on the waterside (WS) end. Sliding metal gate noted in O&M manual. Concrete headwalls located on both WS and landside (LS). O&M manual structure reference is 4'-9" x 9'-6" concrete box culvert. (Automatic Board Order (ABO) issued as Permit No. 9482, 1974 - Elizabeth M. Farnsworth) [Additional Reference(s): DWR Levee Log, 1992. USACE Sacramento O&M Manual 137, August 1955, (Station 370+90)]. FS Date: 5/23/2017 10:14:12 AM

Overview of levee crown looking downstream at crossing.

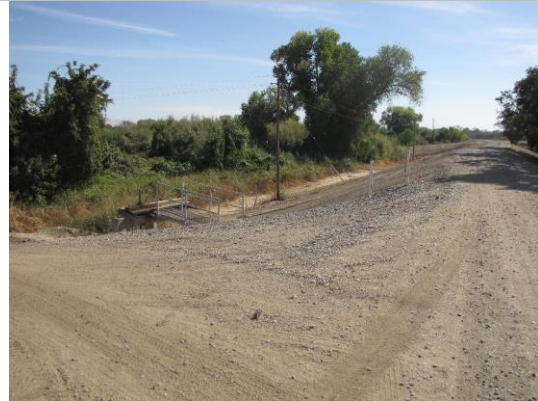
Photo 2 of 3 : UCIP_SP_2017_51875_70187.jpg

FS_ID:51875
DS_ID:16427
EP_NO: 9482
Repair Type: Non-Urgent
Crossing Status: Found
UCIP Comments: 5/3/2017 Abandoned- Needs to be done properly.
(DWR Sutter Yard- A Freitag)10/24/2016 Abandoned.(DWR Sutter Yard- A Freitag)4/25/2016 Abandoned pipe. Needs to be properly plugged if it never gets used.4/20/2015 Same as last inspection. Structure is still buried.6/23/2014 Same as last inspection.12/17/2013 Same as last inspection.7/18/2013 Same as last inspection.10/19/2012 Structure is buried and non-operational. This crossing was listed in the USACE Periodic Inspection as ID# USACE_CESPK_MA1C_2010_p_0288 for sluice gate closed and backfilled on WS and full of sediment with wingwall cracked on LS. FIELD_STRUCT_DESC: *ABANDONED* 1 of 2: 36-inch reinforced concrete irrigation pipe through the levee at approximately 18 feet below the crown. Wooden slide gates on the waterside (WS) end. Sliding metal gate noted in O&M manual. Concrete headwalls located on both WS and landside (LS). O&M manual structure reference is 4'-9" x 9'-6" concrete box culvert. (Automatic Board Order (ABO) issued as Permit No. 9482, 1974 - Elizabeth M. Farnsworth) [Additional Reference(s): DWR Levee Log, 1992. USACE Sacramento O&M Manual 137, August 1955, (Station 370+90)].

WS-walkway and concrete headwall.

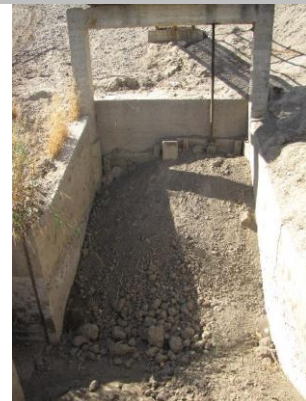
Photo 3 of 3 : UCIP_SP_2017_51875_70190.jpg

View of crossing from WS side. WS blocked by sediment. 2 slide gates part of structure design.

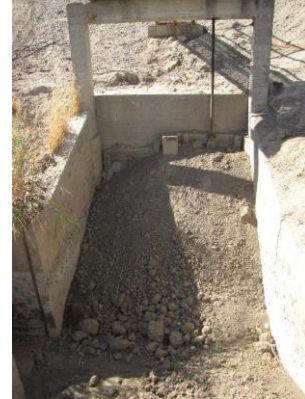
Photo 3 of 3 : UCIP_SP_2017_51876_70196.jpg

Comment Code					
Inspector Comment					
FS_ID:51876 DS_ID:17570 EP_NO: 9482 Repair Type: Non-Urgent Crossing Status: Found UCIP Comments: 5/3/2017 WS slide gate was unburied and crossing was being used for irrigation during site visit.(DWR Sutter Yard-AFreitag)10/24/2016 WS slide gate was unbruied and opened.(DWR Sutter Yard- AFreitag)4/25/2016 WS slide gate was unburied and opened allowing water to flow through to LS fields.4/20/2015 Structure is operational. WS slide gate was unburied allowing water to irrigate the fields. It gets reburied during highwater season. 6/23/2014 Same as last inspection. Soli dug out again and water flowing through crossing.12/17/2013 WS screw gate was closed and buried by soil again.7/18/2013 WS screw gate has been cleared of dirt and is open to irrigate LS fields. LS outlet is still mostly blocked by sediment.10/19/2012 Structure is buried and non-operational. This crossing was listed in the USACE Periodic Inspection as ID# USACE_CESPK_MA1C_2010_p_0288 for sluice gate closed and backfilled on WS and full of sediment with wingwall cracked on LS. FIELD_STRUCT_DESC: 2 of 2: 36-inch reinforced concrete irrigation pipe through the levee, approximately 18 feet below the crown. Wooden slide gates on the waterside (WS) end. Sliding metal gate noted in O&M manual. Concrete structure located on both WS and landside (LS). Inspector noticed that during 2015-2016 that this crossing is used in the spring and summer, and buried in the winter. O&M manual structure reference is 4'-9" x 9'-6" concrete box culvert. (Automatic Board Order (ABO) issued as Permit No. 9482-1974, Elizabeth M. Farnsworth) [Additional Reference(s): DWR Levee Log, 1992. USACE Sacramento O&M Manual 137, August 1955, (Station 370+90)]. FS Date: 5/23/2017 10:15:43 AM

View of crossing from WS. WS blocked by sediment. 2 slide gates part of structure design.

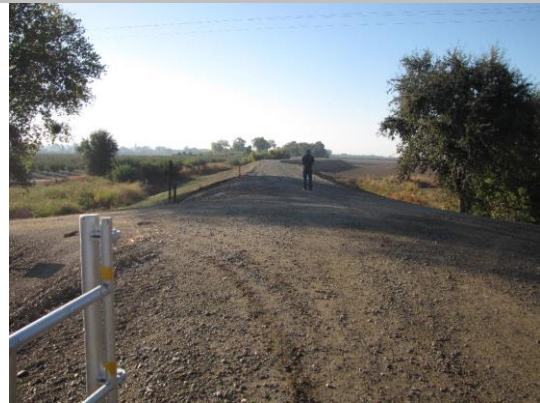
Photo 1 of 3 : UCIP_SP_2017_51877_70202.jpg

Comment Code					
Inspector Comment					
FS_ID:51877 DS_ID:16456 EP_NO: N/A Repair Type: Non-Urgent Crossing Status: Found UCIP Comments: 5/3/2017 Culvert was flowing water during site visit. Appears to be in good condition. Some sediment build up in the bottom of WS box. (DWR Sutter Yard- AFreitag)10/24/2016 Notes mentioned needing to confirm size of the culvert but was unable to access the ends at this inspection.(DWR Sutter Yard- AFreitag)4/25/2016 Second slide gate was held open to allow water to flow through to the LS ditch.4/20/2015 Same as last inspection. Rebar pin was still in place holding the gate opened.6/23/2014 Same as last inspection.12/17/2013 Same as last inspection.7/18/2013 Same as last inspection.10/30/2012 Sediment and debris on waterward and landward side. This crossing was listed in the USACE Periodic Inspection as ID# USACE_CESPK_MA1C_2010_p_0293 for wooden slide gate held open by a piece of rebar acting as a pin. FIELD_STRUCT_DESC: 60-inches by 72-inches (5-foot by 6-foot) reinforced concrete box irrigation culvert (O&M manual references 3-foot and 10-inch by 6-foot culvert) through the levee, approximately 12-15 feet below the crown. Two wooden slide gates on the waterside (WS) end. Concrete v-ditch along landside (LS) toe. [Additional Reference(s): DWR Levee Log, 1992. USACE Sacramento O&M Manual 137, August 1955, (Station 385+33.5)]. FS Date: 5/23/2017 10:27:11 AM

Overview of levee crown looking downstream at crossing.

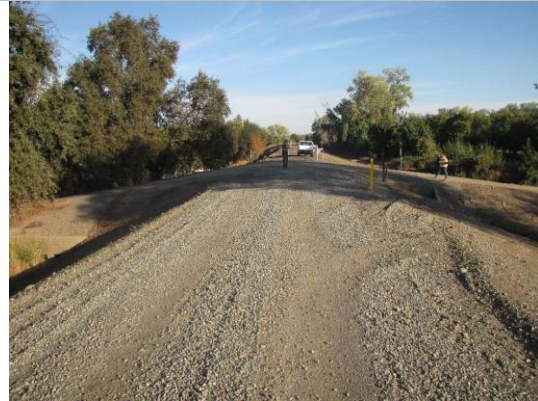
Photo 2 of 3 : UCIP_SP_2017_51877_70204.jpg

FS_ID:51877
DS_ID:16456
EP_NO: N/A
Repair Type: Non-Urgent
Crossing Status: Found
UCIP Comments: 5/3/2017 Culvert was flowing water during site visit. Appears to be in good condition. Some sediment build up in the bottom of WS box. (DWR Sutter Yard- A Freitag)10/24/2016 Notes mentioned needing to confirm size of the culvert but was unable to access the ends at this inspection.(DWR Sutter Yard- A Freitag)4/25/2016 Second slide gate was held open to allow water to flow through to the LS ditch.4/20/2015 Same as last inspection. Rebar pin was still in place holding the gate opened.6/23/2014 Same as last inspection.12/17/2013 Same as last inspection.7/18/2013 Same as last inspection.10/30/2012 Sediment and debris on waterward and landward side. This crossing was listed in the USACE Periodic Inspection as ID# USACE_CESPK_MA1C_2010_p_0293 for wooden slide gate held open by a piece of rebar acting as a pin. FIELD_STRUCT_DESC: 60-inches by 72-inches (5-foot by 6-foot) reinforced concrete box irrigation culvert (O&M manual references 3-foot and 10-inch by 6-foot culvert) through the levee, approximately 12-15 feet below the crown. Two wooden slide gates on the waterside (WS) end. Concrete v-ditch along landside (LS) toe. [Additional Reference(s): DWR Levee Log, 1992. USACE Sacramento O&M Manual 137, August 1955, (Station 385+33.5)].

Overview of levee crown looking upstream at crossing.

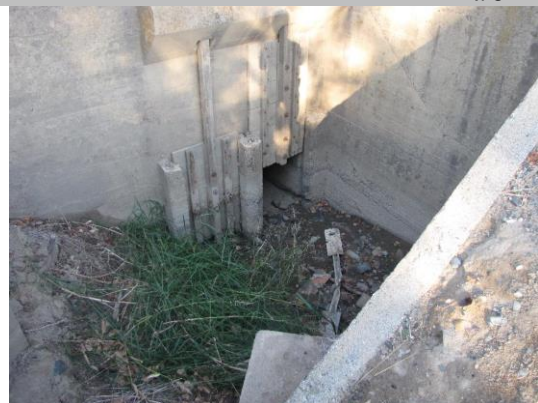
Photo 3 of 3 : UCIP_SP_2017_51877_70203.jpg

View of wooden sluice gates located on WS.

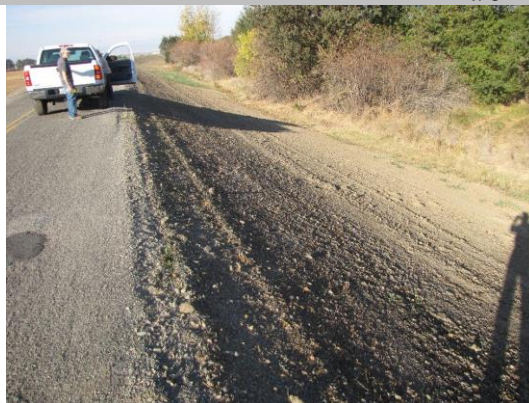
Photo 1 of 3 : UCIP_SP_2017_51878_70209.jpg

FS_ID:51878
DS_ID:16455
EP_NO: 12334
Repair Type: Non-Urgent
Crossing Status: Found
UCIP Comments: 5/3/2017 No LS inlet found and no pump on WS-appears to have been abandoned. If so needs to be done properly. (DWR Sutter Yard- A Freitag) 10/24/2016 Pump removed from WS pipe. Pipe end left open and should be capped. (DWR Sutter Yard- A Freitag) 4/25/2016 No LS inlet found 4/20/2015 Same as last inspection. 6/23/2014 Same as last inspection. 12/17/2013 Same as last inspection. 7/18/2013 Same as last inspection. 10/30/2012 Siphon breaker housing unit is bent and has debris inside. LS outlet not found.
FIELD_STRUCT_DESC: 10-inch asphalt coated steel irrigation pipe through the levee, 3 feet below the crown. Centrifugal pump on the waterside (WS) bank. Siphon breaker on the landside (LS) shoulder of the levee. (Permit No. 12334, 1978 - Jean James) [Additional Reference(s): DWR Levee Log, 1992].
FS Date: 5/23/2017 10:29:58 AM

View of WS-no features on levee shoulder or slope.

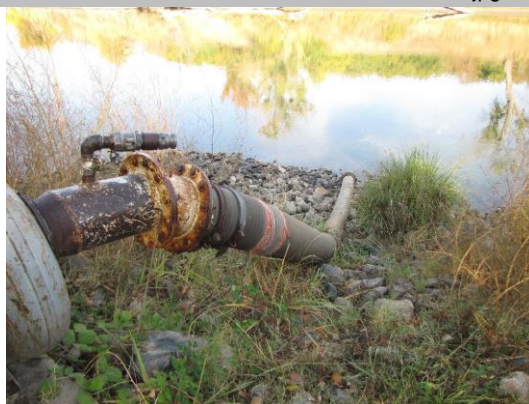
Photo 2 of 3 : UCIP_SP_2017_51878_70210.jpg

Pump located on WS bank.

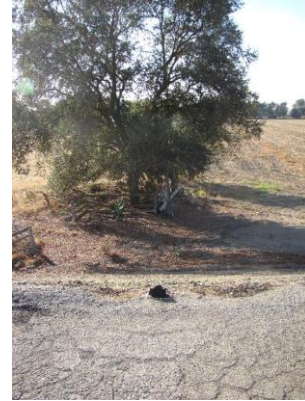
Photo 3 of 3 : UCIP_SP_2017_51878_70211.jpg

Comment Code					
Inspector Comment					
FS_ID:51878 DS_ID:16455 EP_NO: 12334 Repair Type: Non-Urgent Crossing Status: Found UCIP Comments: 5/3/2017 No LS inlet found and no pump on WS- appears to have been abandoned. If so needs to be done properly. (DWR Sutter Yard- A Freitag)10/24/2016 Pump removed from WS pipe. Pipe end left open and should be capped.(DWR Sutter Yard- A Freitag)4/25/2016 No LS inlet found4/20/2015 Same as last inspection.6/23/2014 Same as last inspection.12/17/2013 Same as last inspection.7/18/2013 Same as last inspection.10/30/2012 Siphon breaker housing unit is bent and has debris inside. LS outlet not found. FIELD_STRUCT_DESC: 10-inch asphalt coated steel irrigation pipe through the levee, 3 feet below the crown. Centrifugal pump on the waterside (WS) bank. Siphon breaker on the landside (LS) shoulder of the levee. (Permit No. 12334, 1978 - Jean James) [Additional Reference(s): DWR Levee Log, 1992]. FS Date: 5/23/2017 10:29:58 AM

View of LS with appurtenances present on levee shoulder.

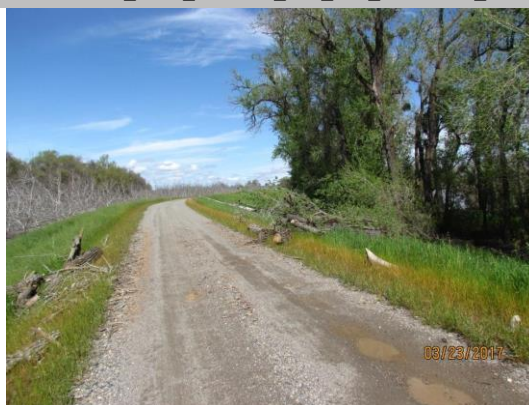
Photo 1 of 1 : SP_2017_MA0001_297_138_20170330_00184.jpg

LM Start	8.34	Rating **	M	Issue No.	138
LM End	8.34	Issue Type +	En	Location *	WS
Category	Earthen Levee		GPS Latitude/Longitude		
			Start	End	
Item	Encroachments		39.302855 °	39.302855 °	
			-122.032230 °	-122.032230 °	
DWR ID	DWR_MA0001_01_s _ 2017_138				
Comment Code					
TR : Tree or limb					
Inspector Comment					
Remove the tree from the waterside slope and toe.

View of the tree on the waterside slope and toe.

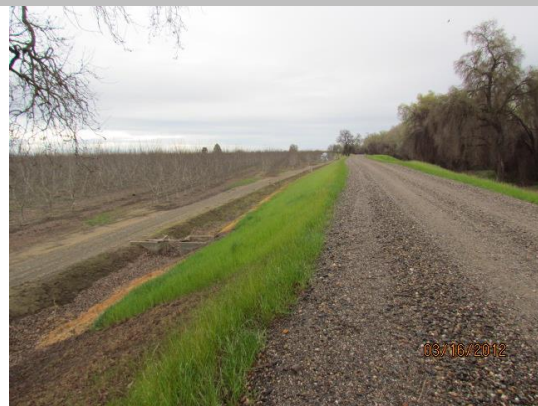
Photo 1 of 1 : SP_2017_MA0001_297_25_20170315_00012.jpg

LM Start	8.73	Rating **	M	Issue No.	25
LM End	9.19	Issue Type +	En	Location *	LS
Category	Earthen Levee			GPS Latitude/Longitude	
				Start	End
Item	Encroachments			39.308390 °	39.315125 °
				-122.031157 °	-122.030206 °
DWR ID	DWR_MA0001_01_s_2012_25				
Comment Code					
DT : Ditch					
Inspector Comment

View of the agricultural ditch along the L/S toe.

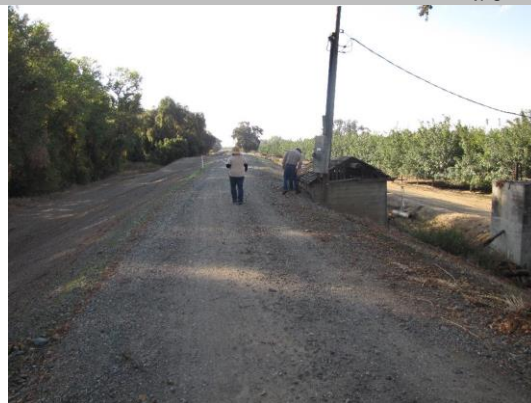
Photo 1 of 3 : UCIP_SP_2017_51879_70219.jpg

FS_ID:51879
DS_ID:16454
EP_NO: 9466
Repair Type: Non-Urgent
Crossing Status: Found
UCIP Comments: 5/3/2017 Abandoned- needs to be done properly. (DWR Sutter Yard- A Freitag)10/24/2016 Abandoned. (DWR Sutter Yard- A Freitag)4/25/2016 Crossing appears to be abandoned. Power lines cut from the panels inside the concrete structure on LS. 4/20/2015 Same as last inspection. 6/23/2014 Same as last inspection. 12/17/2013 Same as last inspection. 7/18/2013 Same as last inspection. 10/30/2012 No access to inspect slide gate on LS. Roof of pumping house deteriorating and debris scattered on LS. WS crossing not found. This crossing was listed in the USACE Periodic Inspection as ID# USACE_CESPK_MA1C_2010_p_345 no issues recorded.
FIELD_STRUCT_DESC: *ABANDONED* 24-inch steel irrigation pipe through the levee, approximately 8-10 feet below the crown. Slide gate in concrete riser on the landside (LS) slope. Pump house encroaches into the LS slope. Two service poles on the LS shoulder. No visible appurtenances found on the waterside (WS) toe. Power source cut on the LS. (Automatic Board Order (ABO) issued as Permit No. 9466, 1974 - Roman Catholic Bishop of Sacramento). [Additional Reference(s): DWR Levee Log, 1992].

Overview of levee crown looking downstream at crossing.

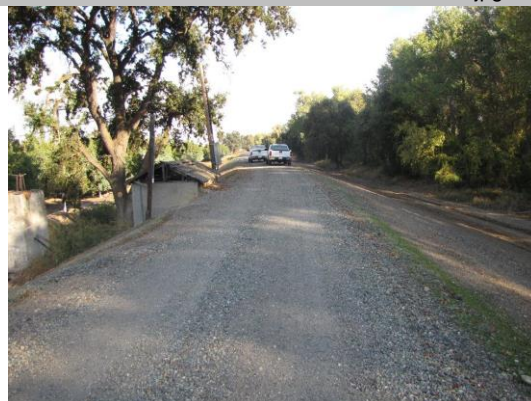
Photo 2 of 3 : UCIP_SP_2017_51879_70217.jpg

Overview of levee crown looking upstream at crossing.

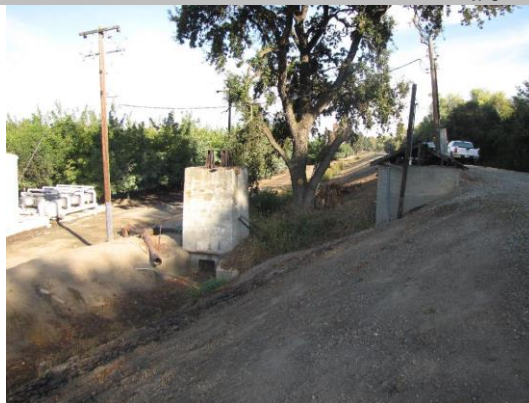
Photo 3 of 3 : UCIP_SP_2017_51879_70218.jpg

Item	DWR UCIP Field Study			39.311103 °	39.311103 °	
				-122.030541 °	-122.030541 °	
DWR ID						
Comment Code						
Inspector Comment						
FS_ID:51879 DS_ID:16454 EP_NO: 9466 Repair Type: Non-Urgent Crossing Status: Found UCIP Comments: 5/3/2017 Abandoned- needs to be done properly. (DWR Sutter Yard- A Freitag)10/24/2016 Abandoned.(DWR Sutter Yard- A Freitag)4/25/2016 Crossing appears to be abandoned. Power lines cut from the panels inside the concrete structure on LS.4/20/2015 Same as last inspection.6/23/2014 Same as last inspection.12/17/2013 Same as last inspection.7/18/2013 Same as last inspection.10/30/2012 No access to inspect slide gate on LS. Roof of pumping house deteriorating and debris scattered on LS. WS crossing not found. This crossing was listed in the USACE Periodic Inspection as ID# USACE_CESPK_MA1C_2010_p_345 no issues recorded. FIELD_STRUCT_DESC: *ABANDONED* 24-inch steel irrigation pipe through the levee, approximately 8-10 feet below the crown. Slide gate in concrete riser on the landside (LS) slope. Pump house encroaches into the LS slope. Two service poles on the LS shoulder. No visible appurtenances found on the waterside (WS) toe. Power source cut on the LS. (Automatic Board Order (ABO) issued as Permit No. 9466, 1974 - Roman Catholic Bishop of Sacramento). [Additional Reference(s): DWR Levee Log, 1992]. FS Date: 5/23/2017 10:31:07 AM

View of pump and standpipe located on LS.

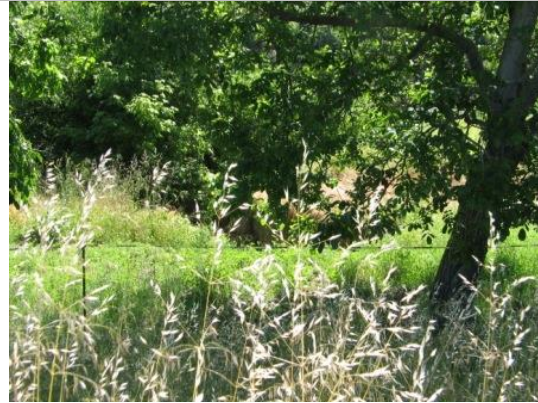
Photo 1 of 1 : SP_2017_MA0001_297_18_20170315_00010.jpg

LM Start	10.13	Rating **	M	Issue No.	18
LM End	10.13	Issue Type +	Ma	Location *	WS
Category	Earthen Levee			GPS Latitude/Longitude	
				Start	End
Item	Erosion / Bank Caving			39.328697 °	39.328697 °
				-122.029262 °	-122.029262 °
DWR ID	DWR_MA0001_01_s_2012_18				
Comment Code					
E1 : Note and monitor erosion site.					
Inspector Comment					
Monitor the erosion site.

View of the erosion along the waterside of the levee.

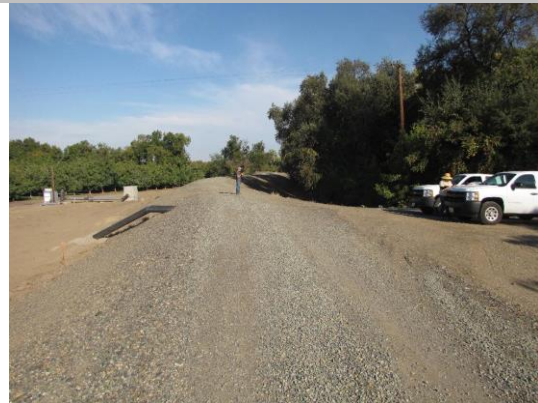
Photo 1 of 3 : UCIP_SP_2017_51883_70236.jpg

LM Start	10.21	Rating **	U	Issue No.	666
LM End	10.21	Issue Type +	En	Location *	WS
Category	Supplemental			GPS Latitude/Longitude	
				Start	End
Item	DWR UCIP Field Study			39.329750 °	39.329750 °
				-122.029602 °	-122.029602 °
DWR ID

Comment Code					
Inspector Comment					
FS_ID:51883 DS_ID:16452 EP_NO: 1800 Repair Type: Urgent Crossing Status: Found UCIP Comments: 5/3/2017 Rain run off erosion still present near pipe on WS sshoulder. (DWR Sutter Yard- AFreitag)10/24/2016 Ws erosion still present. Looks to be just from rain run off.(DWR Sutter Yard- AFreitag)4/25/2016 Erosion still present by the WS pipes. (DWR Sutter Yard - afreitag)4/20/2015 Erosion happening near WS shoulder where the pipes enter the levee. May just be caused by rain runoff. (DWR Sutter Yard - afreitag)6/23/2014 Same as last inspection. (DWR Sutter Yard - afreitag)12/17/2013 Same as last inspection. (DWR Sutter Yard - afreitag)7/18/2013 Same as last inspection. (DWR Sutter Yard - afreitag)10/30/2012 This crossing has been completely modified--need recent permit issued to allow work on levee and levee toe. Was levee compacted to CVFPB standards? This crossing was listed in the USACE Periodic Inspection as ID# USACE_CESPK_MA1C_2010_p_0371 unable to determine why this crossing was assigned "U". (DWR UCIP - omagana) FIELD_STRUCT_DESC: 1 of 2: 14-inch steel irrigation pipe through the levee, approximately 3-4 feet below the crown. Siphon breakers on the waterside (WS) end. (Permit No. 1800, 1959 - Jimeno Rancho) New pipe visible on the landside (LS). [Additional Reference(s): DWR Levee Log, 1992]. FS Date: 5/23/2017 10:36:55 AM

Overview of levee crown looking upstream at crossing.

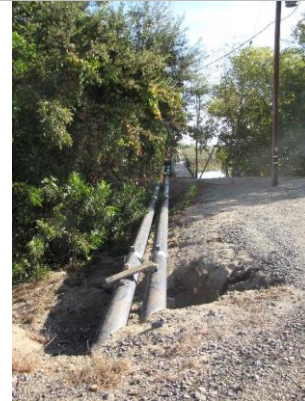
Photo 2 of 3 : UCIP_SP_2017_51883_70235.jpg

FS_ID:51883
DS_ID:16452
EP_NO: 1800
Repair Type: Urgent
Crossing Status: Found
UCIP Comments: 5/3/2017 Rain run off erosion still present near pipe on WS shoulder. (DWR Sutter Yard- AFreitag)10/24/2016 Ws erosion still present. Looks to be just from rain run off.(DWR Sutter Yard- AFreitag)4/25/2016 Erosion still present by the WS pipes. (DWR Sutter Yard - afreitag)4/20/2015 Erosion happening near WS shoulder where the pipes enter the levee. May just be caused by rain runoff. (DWR Sutter Yard - afreitag)6/23/2014 Same as last inspection. (DWR Sutter Yard - afreitag)12/17/2013 Same as last inspection. (DWR Sutter Yard - afreitag)7/18/2013 Same as last inspection. (DWR Sutter Yard - afreitag)10/30/2012 This crossing has been completely modified--need recent permit issued to allow work on levee and levee toe. Was levee compacted to CVFPB standards? This crossing was listed in the USACE Periodic Inspection as ID# USACE_CESPK_MA1C_2010_p_0371 unable to determine why this crossing was assigned "U". (DWR UCIP - omagana)

View of 2-14 inch crossings through levee on WS.

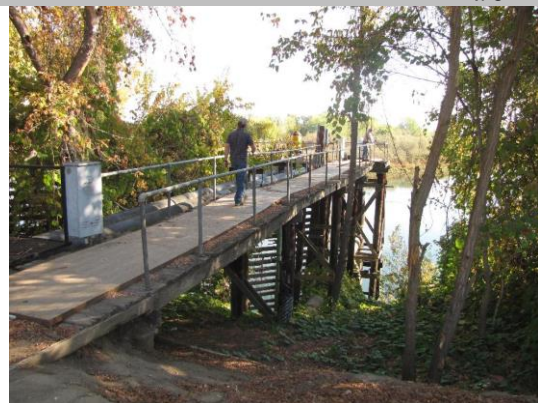
Photo 3 of 3 : UCIP_SP_2017_51883_70240.jpg

Catwalk, control panel, and pump station located on WS.

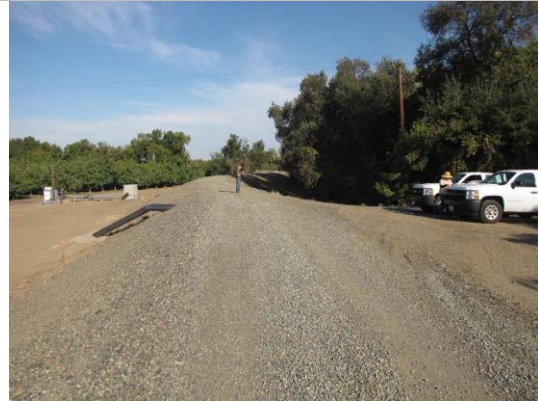
Photo 1 of 3 : UCIP_SP_2017_51884_70228.jpg

FS_ID:51884
DS_ID:17571
EP_NO: 1800
Repair Type: Urgent
Crossing Status: Found
UCIP Comments: 5/3/2017 Rain runoff erosion still present near pipes on WS shoulder. (DWR Sutter Yard- A Freitag)10/24/2016 Ws erosion still present. Looks to be just from rain run off.(DWR Sutter Yard- A Freitag)4/25/2016 Erosion still present near the WS pipes. (DWR Sutter Yard - a Freitag)4/20/2015 Erosion happening on WS shoulder near where pipes enter the levee. May just be from rain runoff. (DWR Sutter Yard - a Freitag)6/23/2014 Same as last inspection. (DWR Sutter Yard - a Freitag)12/17/2013 Same as last inspection. (DWR Sutter Yard - a Freitag)7/18/2013 Same as last inspection. (DWR Sutter Yard - a Freitag)10/30/2012 This crossing has been completely modified--need recent permit issued to allow work on levee and levee toe. Was levee compacted to CVFPB standards? This crossing was listed in the USACE Periodic Inspection as ID# USACE_CESPK_MA1C_2010_p_0371 unable to determine why this crossing was assigned "U". (DWR UCIP - omagana)

Overview of levee crown looking upstream at crossing.

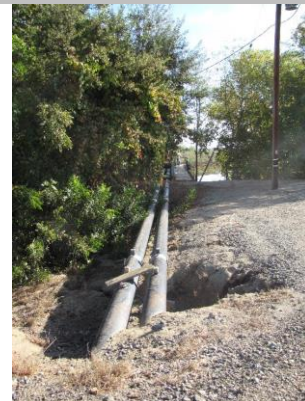
Photo 2 of 3 : UCIP_SP_2017_51884_70227.jpg

View of WS looking at crossing.

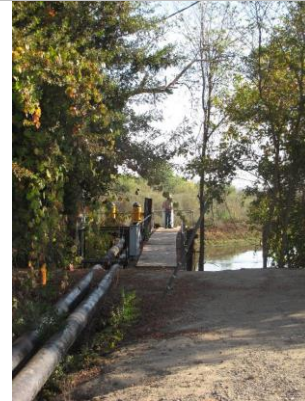
Photo 3 of 3 : UCIP_SP_2017_51884_70226.jpg

Item	DWR UCIP Field Study			39.329750 °	39.329750 °	
				-122.029602 °	-122.029602 °	
DWR ID						
Comment Code						
Inspector Comment						
FS_ID:51884 DS_ID:17571 EP_NO: 1800 Repair Type: Urgent Crossing Status: Found UCIP Comments: 5/3/2017 Rain runoff erosion still present near pipes on WS shoulder. (DWR Sutter Yard- AFreitag)10/24/2016 Ws erosion still present. Looks to be just from rain run off.(DWR Sutter Yard- AFreitag)4/25/2016 Erosion still present near the WS pipes. (DWR Sutter Yard - afreitag)4/20/2015 Erosion happening on WS shoulder near where pipes enter the levee. May just be from rain runoff. (DWR Sutter Yard - afreitag)6/23/2014 Same as last inspection. (DWR Sutter Yard - afreitag)12/17/2013 Same as last inspection. (DWR Sutter Yard - afreitag)7/18/2013 Same as last inspection. (DWR Sutter Yard - afreitag)10/30/2012 This crossing has been completely modified--need recent permit issued to allow work on levee and levee toe. Was levee compacted to CVFPB standards? This crossing was listed in the USACE Periodic Inspection as ID# USACE_CESPK_MA1C_2010_p_0371 unable to determine why this crossing was assigned "U". (DWR UCIP - omagana) FIELD_STRUCT_DESC: 2 of 2: 14-inch steel irrigation pipe through the levee, approximately 3-4 feet below the crown. Siphon breaker located on the waterside (WS) end. (Permit No. 1800, 1959 - Jimeno Rancho) [Additional Reference(s): DWR Levee Log, 1992]. FS Date: 5/23/2017 10:37:52 AM

View of catwalk and pump station located on WS.

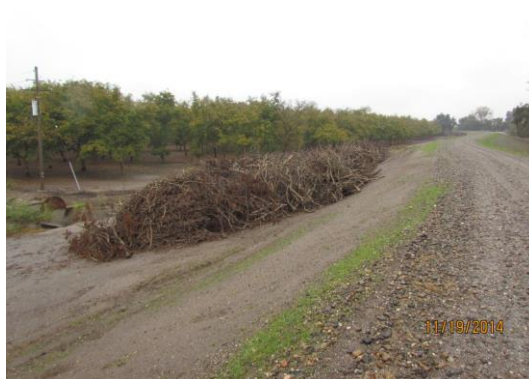
Photo 1 of 1 : SP_2017_MA0001_297_637_20170315_00065.jpg

LM Start	10.78	Rating **	A/W	Issue No.	637
LM End	10.78	Issue Type +	En	Location *	LS
Category	Earthen Levee			GPS Latitude/Longitude	
				Start	End
Item	Encroachments			39.337523 °	39.337523 °
				-122.032437 °	-122.032437 °
DWR ID	DWR_MA0001_01_f_2014_637				
Comment Code					
PR : Prunings					
Inspector Comment

View of the pruning along the landside toe.

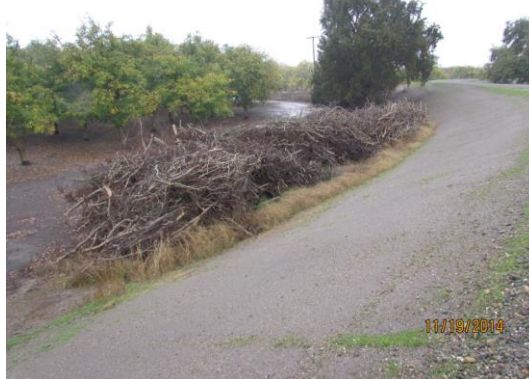
Photo 1 of 1 : SP_2017_MA0001_297_638_20170315_00066.jpg

LM Start	10.96	Rating **	M	Issue No.	638
LM End	10.96	Issue Type +	En	Location *	LS
Category	Earthen Levee			GPS Latitude/Longitude	
				Start	End
Item	Encroachments			39.340217 °	39.340217 °
				-122.032605 °	-122.032605 °
DWR ID	DWR_MA0001_01_f_2014_638				
Comment Code					
PR : Prunings					
Inspector Comment					
Remove prunings from the landside toe.

View of the pruning along the landside toe.

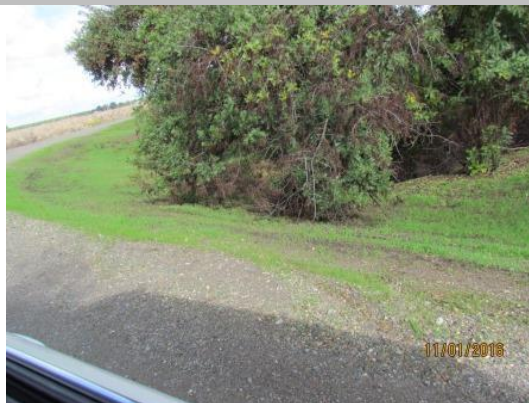
Photo 1 of 1 : SP_2017_MA0001_297_120_20170315_00049.jpg

LM Start	11.00	Rating **	M	Issue No.	120
LM End	11.00	Issue Type +	Ma	Location *	WS
Category	Earthen Levee			GPS Latitude/Longitude	
				Start	End
Item	Trim / Thin Trees			39.340728 °	39.340728 °
				-122.032897 °	-122.032897 °
DWR ID	DWR_MA0001_01_f_2016_120				
Comment Code					
T1 : Trim trees to at least five feet above ground level.					
Inspector Comment

View of the tree with overhanging branches.

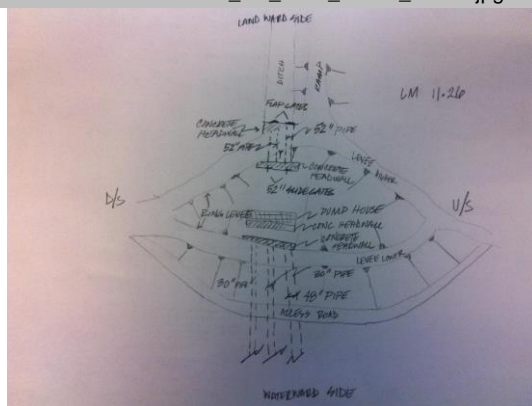
Photo 1 of 3 : UCIP_SP_2017_51889_70267.jpg

FS_ID:51889
DS_ID:16449
EP_NO: 187
Repair Type: Non-Urgent
Crossing Status: Found
UCIP Comments: 5/3/2017 No changes have been made to this crossing since the NOV was sent out in January 2017. (DWR Sutter Yard- A Freitag)01/31/2017 Informal Notice of Violation (NOV) was sent out January 31, 2017 by DWR Flood Maintenance Office--owner will need to coordinate with CVFPB to remove, replace, or abandon pipe in-place. Owner has until Monday February 27th, 2017 to respond to DWR contact: Bryan Reniff. (refer to Official Notice for details). (DWR UCIP - O. Magana)10/24/2016 Appears abandoned. Slide gate needs to be dug out and fully closed to prevent water flow during high water.(DWR Sutter Yard- A Freitag)4/25/2016 Crossing appears to be abandoned.4/21/2015 Same as last inspection.6/23/2014 Same as last inspection.12/17/2013 Same as last inspection.7/18/2013 Same as last inspection.10/30/2012 Need to determine if structure is still in use--contact owner. If abandoned structure--structure needs to be properly abandoned. This crossing was listed in the USACE Periodic Inspections as ID# USACE_CESPK_MA1C_2010_p_0393 missing gate. FIELD_STRUCT_DESC: 1 of 2: 52-inch corrugated metal irrigation pipe, 48-inch measured, through the levee, approximately 15 feet below the crown. Slide gate on the waterside (WS) and flap gate on the landside (LS). Concrete headwalls at both WS and LS. This structure is associated with another abandoned structure located on the WS. Abandoned structure includes pump house, multiple concrete walls, and 3 additional crossings (two 30-inch pipes and one 48-inch pipe). (Original structure installed under Permit No. 187, 1921 - Compton-Delevan Irrigation District-Maxwell I.D., new pump and platform installed and old pump house removed under Permit No. 9183-1973, Maxwell Irrigation District) [Additional Reference(s): DWR Levee Log, 1992].

Sketch of structure located at levee mile 11.26.

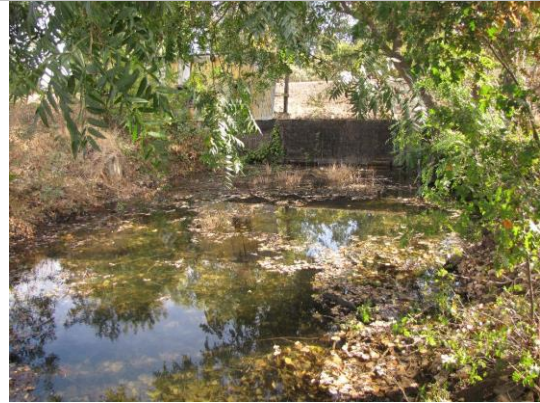
Photo 3 of 3 : UCIP_SP_2017_51889_70260.jpg

FS_ID:51889
DS_ID:16449
EP_NO: 187
Repair Type: Non-Urgent
Crossing Status: Found
UCIP Comments: 5/3/2017 No changes have been made to this crossing since the NOV was sent out in January 2017. (DWR Sutter Yard- AFreitag)01/31/2017 Informal Notice of Violation (NOV) was sent out January 31, 2017 by DWR Flood Maintenance Office--owner will need to coordinate with CVFPB to remove, replace, or abandon pipe in-place. Owner has until Monday February 27th, 2017 to respond to DWR contact: Bryan Reniff. (refer to Official Notice for details). (DWR UCIP - O. Magana)10/24/2016 Appears abandoned. Slide gate needs to be dug out and fully closed to prevent water flow during high water.(DWR Sutter Yard- AFreitag)4/25/2016 Crossing appears to be abandoned.4/21/2015 Same as last inspection.6/23/2014 Same as last inspection.12/17/2013 Same as last inspection.7/18/2013 Same as last inspection.10/30/2012 Need to determine if structure is still in use--contact owner. If abandoned structure--structure needs to be properly abandoned. This crossing was listed in the USACE Periodic Inspections as ID# USACE_CESPK_MA1C_2010_p_0393 missing gate. FIELD_STRUCT_DESC: 1 of 2: 52-inch corrugated metal irrigation pipe, 48-inch measured, through the levee, approximately 15 feet below the crown. Slide gate on the waterside (WS) and flap gate on the landside (LS). Concrete headwalls at both WS and LS. This structure is associated with another abandoned structure located on the WS. Abandoned structure includes pump house, multiple concrete walls, and 3 additional crossings (two 30-inch pipes and one 48-inch pipe). (Original structure installed under Permit No. 187, 1921 - Compton-Delevan Irrigation District-Maxwell I.D., new pump and platform installed and old pump house removed under Permit No. 9183-1973, Maxwell Irrigation District) [Additional Reference(s): DWR Levee Log, 1992].

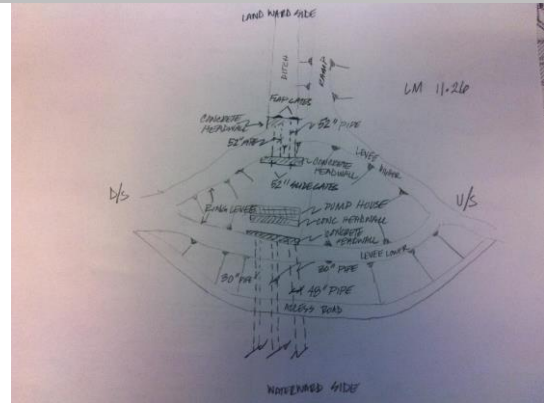
Photo 1 of 3 : UCIP_SP_2017_51891_70272.jpg

FS_ID:51891
DS_ID:17572
EP_NO: 187
Repair Type: Urgent
Crossing Status: Found
UCIP Comments: 5/3/2017 No changes have been made at this crossing since the NOV was sent out in January 2017. (DWR Sutter Yard- A Freitag)01/31/2017 Informal Notice of Violation (NOV) was sent out January 31, 2017 by DWR Flood Maintenance Office--owner will need to coordinate with CVFPB to remove, replace, or abandon pipe in-place. Owner has until Monday February 27th, 2017 to respond to DWR contact: Bryan Reniff. (refer to Official Notice for details). (DWR UCIP - O. Magana)10/24/2016 Appears abandoned. Slide gate needs to be replaced or pipe end capped to prevent water flow during high water. (DWR Sutter Yard- A Freitag)4/25/2016 Crossing appears to be abandoned. Slide gate needs to be replaced or pipe needs to be plugged to prevent water flow during high water season. (DWR Sutter Yard - a Freitag)4/21/2015 Same as last inspection. (DWR Sutter Yard - a Freitag)6/23/2014 Same as last inspection. (DWR Sutter Yard - a Freitag)12/17/2013 Same as last inspection. (DWR Sutter Yard - a Freitag)7/18/2013 Same as last inspection. (DWR Sutter Yard - a Freitag)10/30/2012 Missing positive closure device. Need to determine if structure is still in use--contact owner. If abandoned structure--structure needs to be abandoned properly. This crossing was listed in the USACE Periodic Inspections as ID# USACE_CESPK_MA1C_2010_p_0393 missing gate. (DWR UCIP - omagana)

FIELD_STRUCT_DESC: 2 of 2: 52-inch corrugated metal irrigation pipe, 48-inch measured (2012), through the levee, approximately 15 feet below the crown. Slide gate on the waterside (WS) and flap gate on the landside (LS). Concrete headwalls at both ends. This structure is associated with another abandoned structure located on the WS. Abandoned structure includes pump house, multiple concrete walls, and 3 additional crossings (two 30-inch pipes and one 48-inch pipe). (Original structure installed under Permit No. 187, 1921 - Compton-Delevan Irrigation District-Maxwell I.D., new pump and platform installed and old pump house removed under Permit No. 9183-1973, Maxwell Irrigation District) [Additional Reference(s): DWR Levee Log, 1992].
FS Date: 5/23/2017 10:48:04 AM

Sketch of structure through levee ring located at levee mile 11.26.

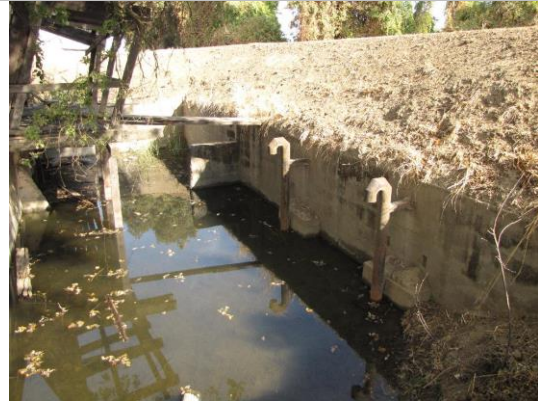
Photo 3 of 3 : UCIP_SP_2017_51891_70275.jpg

FS_ID:51891
DS_ID:17572
EP_NO: 187
Repair Type: Urgent
Crossing Status: Found
UCIP Comments: 5/3/2017 No changes have been made at this crossing since the NOV was sent out in January 2017. (DWR Sutter Yard- A Freitag)01/31/2017 Informal Notice of Violation (NOV) was sent out January 31, 2017 by DWR Flood Maintenance Office--owner will need to coordinate with CVFPB to remove, replace, or abandon pipe in-place. Owner has until Monday February 27th, 2017 to respond to DWR contact: Bryan Reniff. (refer to Official Notice for details). (DWR UCIP - O. Magana)10/24/2016 Appears abandoned. Slide gate needs to be replaced or pipe end capped to prevent water flow during high water. (DWR Sutter Yard- A Freitag)4/25/2016 Crossing appears to be abandoned. Slide gate needs to be replaced or pipe needs to be plugged to prevent water flow during high water season. (DWR Sutter Yard - A Freitag)4/21/2015 Same as last inspection. (DWR Sutter Yard - A Freitag)6/23/2014 Same as last inspection. (DWR Sutter Yard - A Freitag)12/17/2013 Same as last inspection. (DWR Sutter Yard - A Freitag)7/18/2013 Same as last inspection. (DWR Sutter Yard - A Freitag)10/30/2012 Missing positive closure device. Need to determine if structure is still in use--contact owner. If abandoned structure--structure needs to be abandoned properly. This crossing was listed in the USACE Periodic Inspections as ID# USACE_CESPK_MA1C_2010_p_0393 missing gate. (DWR UCIP - O Magana)

WS-Concrete headwall with multiple crossings (2-30 inch pipes and 1-48 inch pipe).

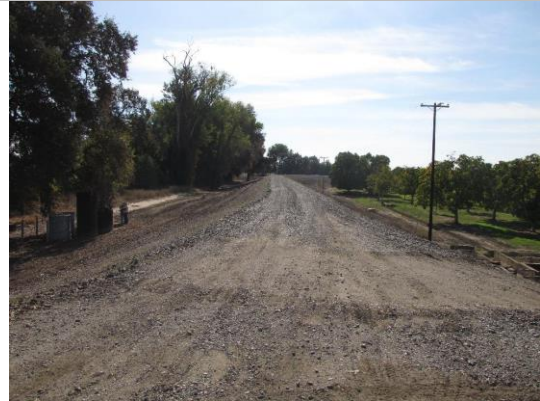
Photo 1 of 3 : UCIP_SP_2017_51893_70327.jpg

FS_ID:51893
DS_ID:17691
EP_NO: 17471
Repair Type: Urgent
Crossing Status: Found
UCIP Comments: 5/3/2017 Sink hole still present between the WS risers. It does not appears to be getting worse. Pumps were running during site visit but the sink hole was dry this time. (DWR Sutter Yard- A Freitag)10/24/2016 Sinkhole still present.(DWR Sutter Yard- A Freitag)4/25/2016 Sink hole between the standpipes seems to be getting worse. Measurements of the hole are 3' wide x 3' long x 3' deep. The pipe was flowing water and there was water present in the bottom of the sink hole. (DWR Sutter Yard - a Freitag)4/21/2015 Sink hole still present between risers. (DWR Sutter Yard - a Freitag)6/23/2014 Standing water was present in the bottom of the sinkhole. (DWR Sutter Yard - a Freitag)12/17/2013 Same as last inspection. (DWR Sutter Yard - a Freitag)7/18/2013 Same as last inspection. (DWR Sutter Yard - a Freitag)10/30/2012 Erosion between risers with slide gates located on waterward side; This crossing was listed in the USACE Periodic Inspections as ID# USACE_CESPK_MA1C_2010_p_0398 for possible sinkhole between access gate structures. (DWR UCIP - omagana)

Overview of levee crown looking downstream at crossing.

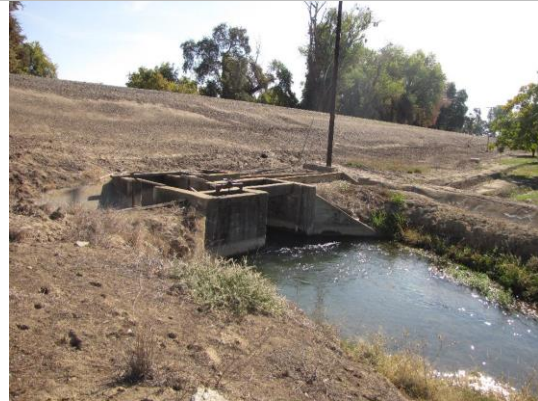
Photo 2 of 3 : UCIP_SP_2017_51893_70326.jpg

Comment Code					
Inspector Comment					
FS_ID:51893 DS_ID:17691 EP_NO: 17471 Repair Type: Urgent Crossing Status: Found UCIP Comments: 5/3/2017 Sink hole still present between the WS risers. It does not appears to be getting worse. Pumps were running during site visit but the sink hole was dry this time. (DWR Sutter Yard- A Freitag)10/24/2016 Sinkhole still present.(DWR Sutter Yard- A Freitag)4/25/2016 Sink hole between the standpipes seems to be getting worse. Measurements of the hole are 3' wide x 3' long x 3' deep. The pipe was flowing water and there was water present in the bottom of the sink hole. (DWR Sutter Yard - a Freitag)4/21/2015 Sink hole still present between risers. (DWR Sutter Yard - a Freitag)6/23/2014 Standing water was present in the bottom of the sinkhole. (DWR Sutter Yard - a Freitag)12/17/2013 Same as last inspection. (DWR Sutter Yard - a Freitag)7/18/2013 Same as last inspection. (DWR Sutter Yard - a Freitag)10/30/2012 Erosion between risers with slide gates located on waterward side; This crossing was listed in the USACE Periodic Inspections as ID# USACE_CESPK_MA1C_2010_p_0398 for possible sinkhole between access gate structures. (DWR UCIP - omagana) FIELD_STRUCT_DESC: 1 of 2: 24-inch high-density polyethylene (HDPE) irrigation pipe to be connected to the existing corrugated metal pipe (CMP) riser within the waterside (WS) and parallel to the right (west) bank levee of the Sacramento River. (Permit 17471, 2002 - Maxwell Irrigation District). FS Date: 5/23/2017 10:52:09 AM

View of concrete distribution box located on LS toe.
